# ULPOWER AERO ENGINES N.V.

## SERVICE BULLETIN

Service Bulletin No. 2015-01

SUBJECT: Alternator fan

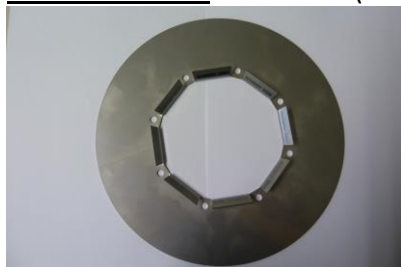
Problem the small fixation flaps (with Ø6 mm hole) might be cracked

Solution: Replace the old style alternator fan base by the new style alternator fan base .  
(no more flaps)

order part E052505C

Unscrew 8 bolts n° 32

Remove the complete alternator fan (28 + 29 + 30)

Change part 28 old style fan base to new style fan base

Replace the complete alternator fan (28 new style + 29 +30)

Tighten the 8 bolts n°32 to 10Nm
