ULPOWER AERO ENGINES N.V.

SERVICE BULLETIN

Service Bulletin No. 2016-02

SUBJECT: Bolts valve cover plate + bolts inlet manifold

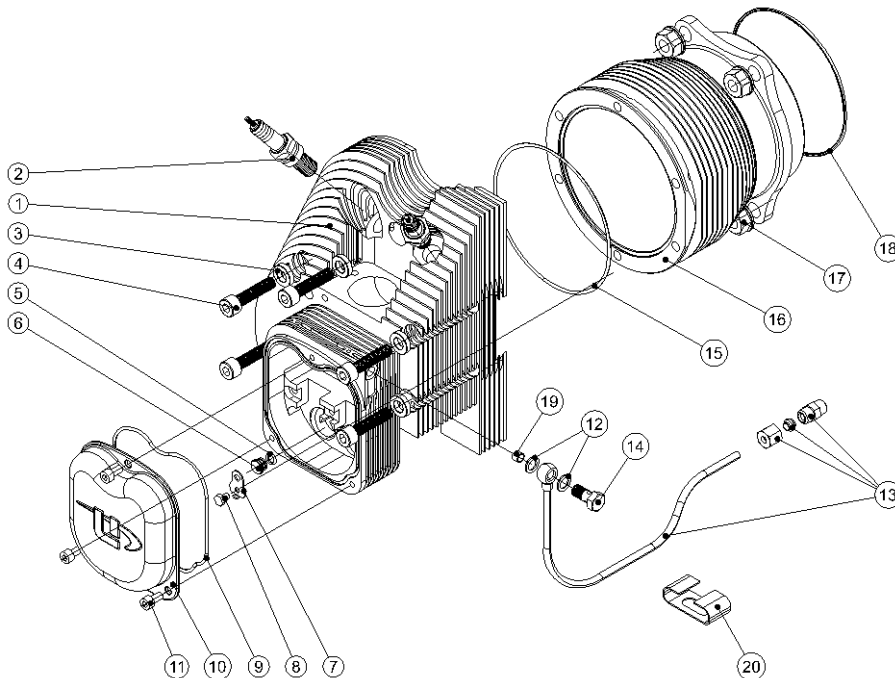
One operator mentioned his valve cover bolts (item 11) loosened. This may have been caused by vibrations.

Therefore we advise you to check them regularly and tighten them at 6 nm.

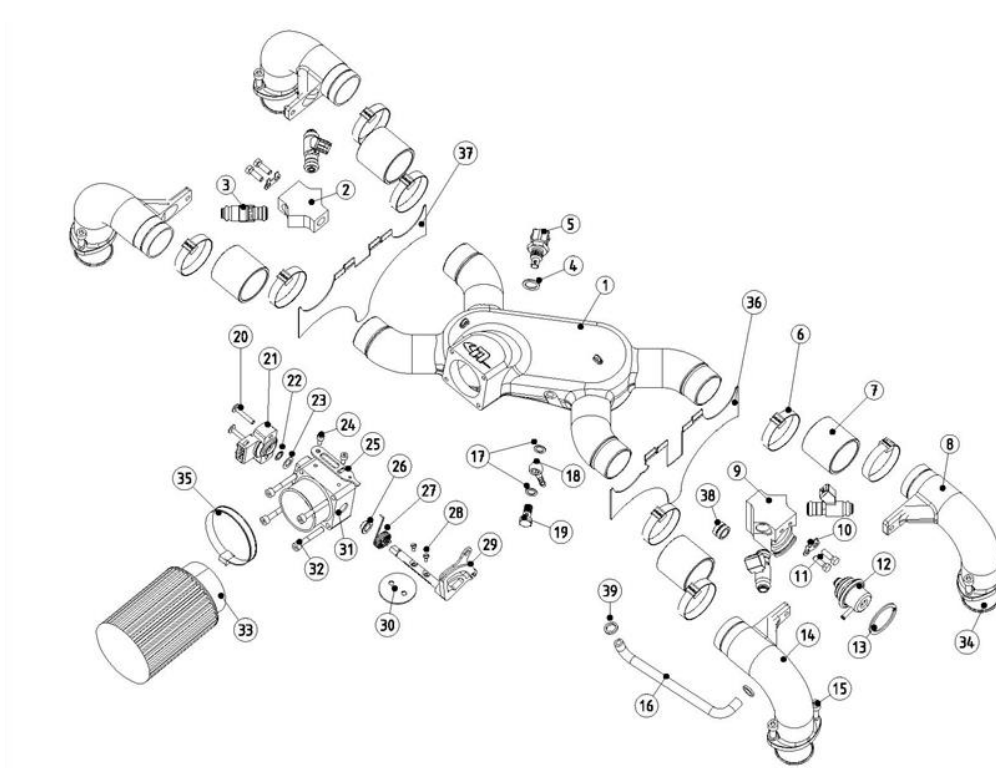
Same thing might happen with the bolts from the intake manifold (item 15).
To avoid problems, apply Red Loctite 266.
