ULPOWER AERO ENGINES N.V.

SERVICE BULLETIN

Service Bulletin No. 2018-03

SUBJECT: Throttle position sensor

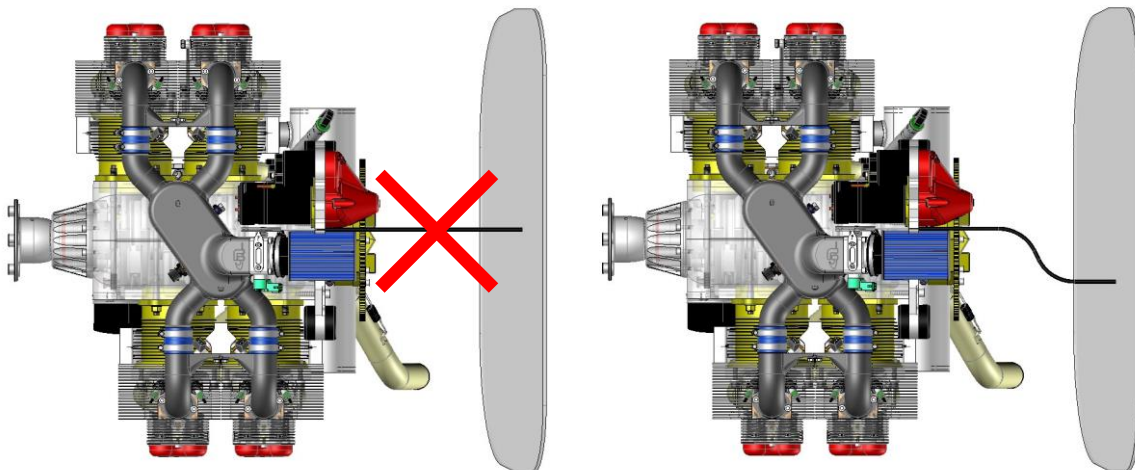
We have noticed early wear of the throttle position sensor (TPS) in aircraft where the throttle cable was not installed in accordance with the official ULPower installation manuals .

When a throttle cable is installed in a straight line from the throttle lever to the fire wall , or when the lever is controlled by a push/pull (or similar) system, engine vibrations create a non-stop movement of the TPS's brushes on the copper lane, resulting in an early wear of the TPS. This may lead to an incorrect signal to the ECU and a possible engine stoppage in flight.

INCORRECT

CORRECT

If your throttle cable is installed the correct way, no further action is required

If your throttle cable is installed incorrectly, please follow the instructions below

2) Install the throttle cable according to the manuals and replace the throttle body +TPS
