ULPOWER AERO ENGINES N.V.

DATE: September 24, 2010 Service Bulletin No. 2010-01

SUBJECT: Propeller flange bolt locking

MODELS AFFECTED: UL260i / UL260iS

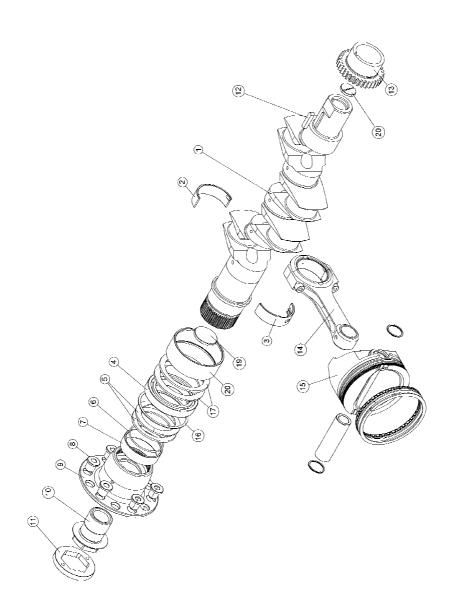
ULPower has determined that the 'Nord lock washer' used to lock the propeller flange bolt is not reliable. Because of this, ULPower changed the way of locking. Instead of the Nord lock washer, ULPower now uses a hexagonal locking washer (part no. 11, see fig. 1).

- Order part 11 (see figure 1), ref. No. E022510B. And the necessary special tools.
- Remove the propeller
- Tighter the bolt no. 10 clockwise to 300 Nm. Use the special tool to hold the propeller flange
- Slide the washer (E022510B) over the hexagonal part of the propeller flange bolt (see figure 2)
- Drill a hole dia 5 through the propeller flange and in the middle of the hexagonal locking washer (see figure 2)
- Cut M6 threat till the bottom of the hole (figure 2)
- Use a hexagon socket screw M6x15 and fix it with Loctite 243
- Lock the screw again by punching 2 dimples (see picture 2)
- Replace the propeller

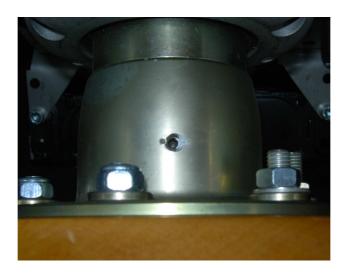
PICTURE 1

- I. <u>Inspection procedure to find out if the hexagonal locking washer is already mounted.</u>
 - Disconnect all power to engine
 - Make sure the engine is cool to the touch
 - Find out if the M6 bolt is mounted through the propeller flange: see picture 1

- If the bolt is there, then you are sure that the locking way is safe
- If there is no bolt, follow procedure below
