ULPOWER AERO ENGINES N.V.

SERVICE BULLETIN

Service Bulletin No. 2012-01

SUBJECT: Alternator fan

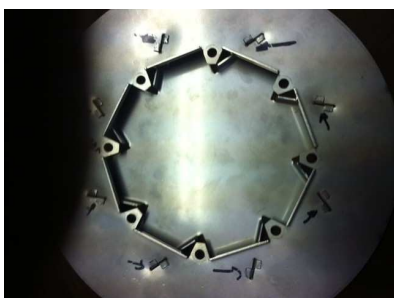
picture 1

Original the 2 parts of the fan were connected to each other by bended flaps. See picture 1.

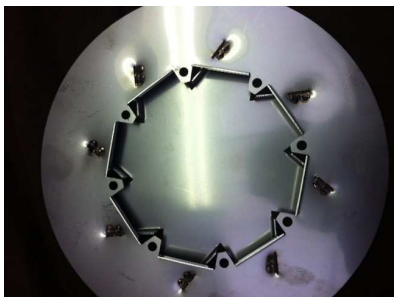
picture 2

Because the connection can come loose. ULPower redesigns and the two parts are now welded to each other. See picture 2.

However, even this connection can come loose. Because of vibration the bended flaps break. ULPower need to change urgent the design!
