ULPOWER AERO ENGINES N.V.

SERVICE BULLETIN

Service Bulletin No. 2014-01

SUBJECT: oil pickup tube

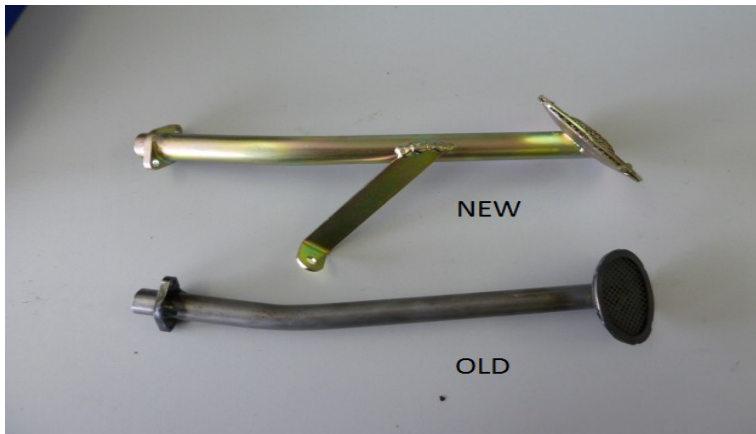
Picture 1

The 'OLD' type oil pickup tube (see picture 1 – OLD) was only fixed with the welded flange to the crankcase.

Later on we added a bracket to have a second fixing point (see picture 1 – NEW).

Vibrations can lead to a crack in the welding on the 'OLD' type and total loss of oil pressure. Since we had, because of that, an engine failure in the UK, UL260i + UL260iF + UL260iS with serial number less than 13 00 00 need to replace the oil pick up tube.

Replace the 'OLD' type oil pickup tube by the 'NEW' type (E044510).
