ULPOWER AERO ENGINES N.V.

SERVICE BULLETIN

Service Bulletin No. 2015-01

SUBJECT: Alternator fan

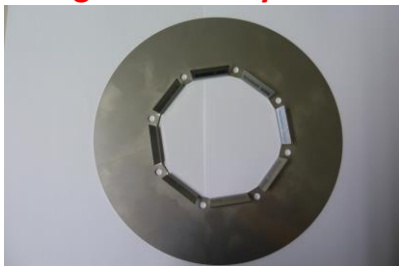
Problem the small fixation flaps (with Ø6 mm hole) might be cracked

Solution: Replace the old style alternator fan base by the new style alternator fan base .
(no more flaps)

order part E052505C
Unscrew 8 bolts n° 32
Remove the complete alternator fan (28 + 29 + 30)
Change part 28 old style fan base to new style fan base
Replace the complete alternator fan (28 new style + 29 +30)
Tighten the 8 bolts n°32 to 10Nm
