ULPOWER AERO ENGINES N.V.

SERVICE BULLETIN

Service Bulletin No. 2018-03

SUBJECT: Throttle position sensor

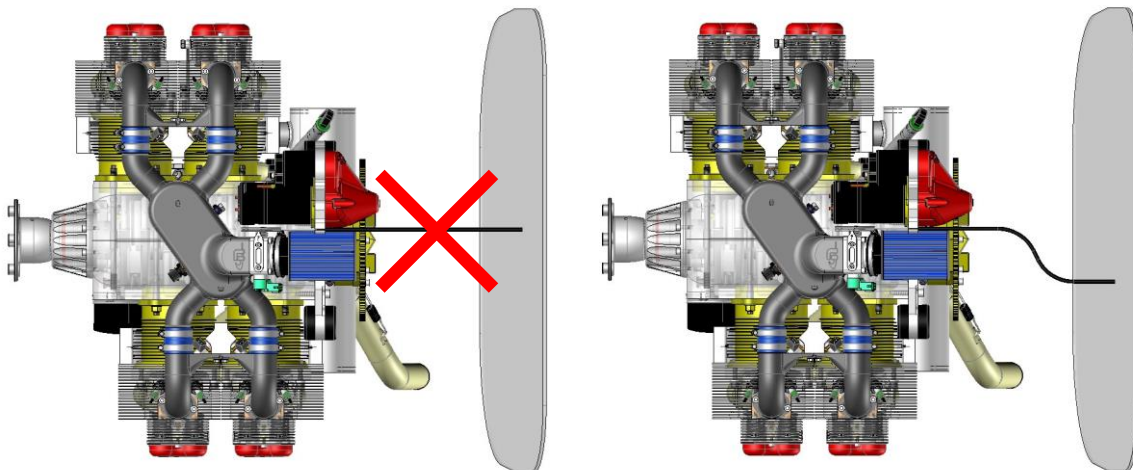
When a throttle cable is installed in a straight line from the throttle lever to the fire wall , or when the lever is controlled by a push/pull (or similar) system, engine vibrations create a non-stop movement of the TPS's brushes on the copper lane, resulting in an early wear of the TPS. This may lead to an incorrect signal to the ECU and a possible engine stoppage in flight.

INCORRECT

CORRECT

If your throttle cable is installed the correct way, no further action is required

If your throttle cable is installed incorrectly, please follow the instructions below

2) Install the throttle cable according to the manuals and replace the throttle body +TPS
