# ULPOWER AERO ENGINES N.V.

## SERVICE INSTRUCTION

Service Instruction No. 2020-02-RECTIFIED

### Inspection of Hall Sensors for possible oil weep.

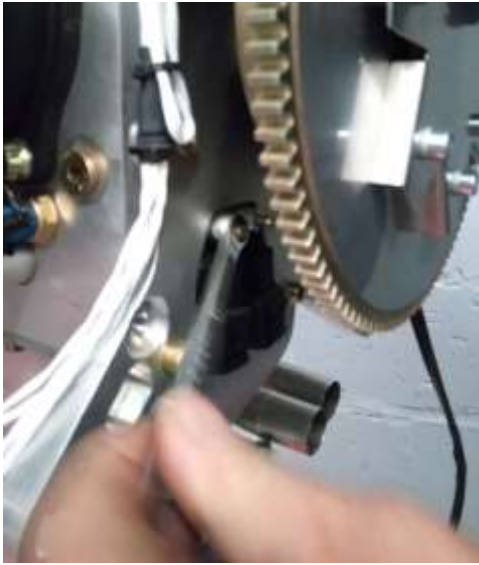
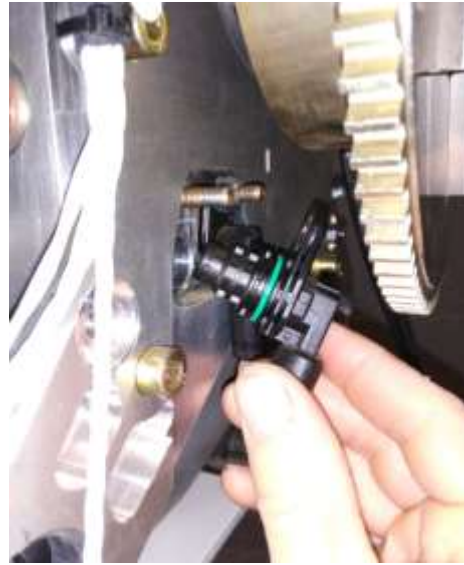
When removing the sensor, oil may leak out from the crankcase. Keep the sensor mounting holes clean and make sure that no dust/dirt can enter the crankcase.

- 3) Unscrew the 2 hexagon M6 nuts (IPC item 14) which hold the hall sensors.  
Gently pull the sensor out of the backplate
