SERVICE BULLETIN

Service Bulletin No. 2021-01

Possible interference between the oil pick tube and adaptor in UL260ISA and UL350ISA.

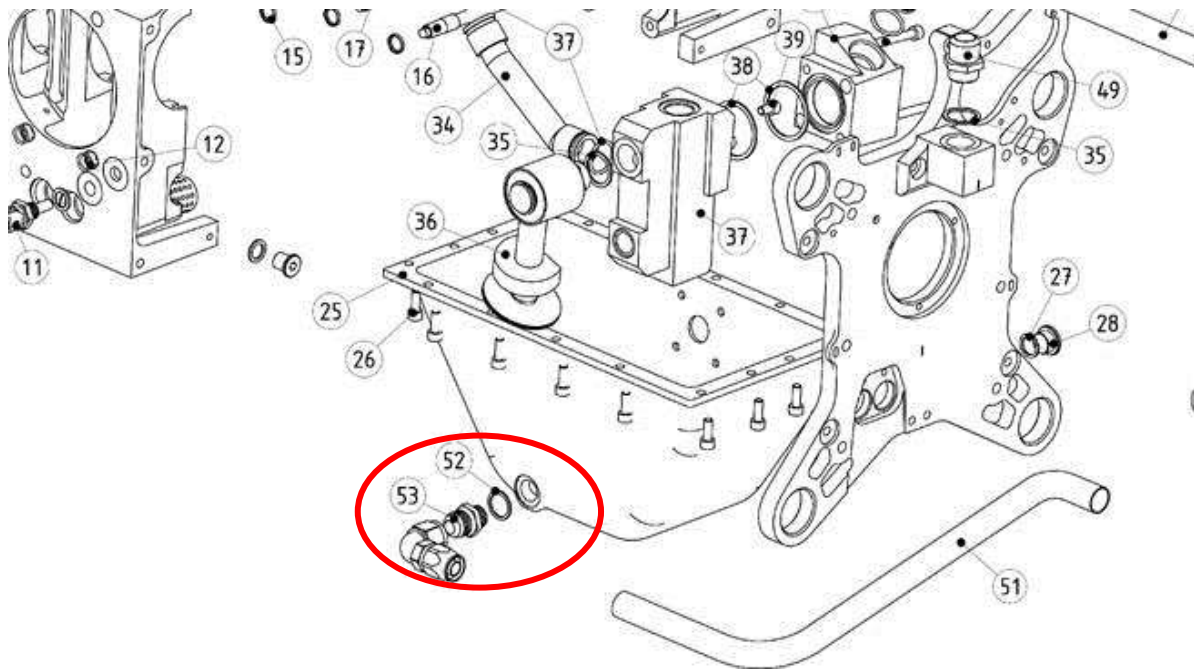
While repairing an aerobatic engine, our mechanics found some abnormal scratches on the oil pick up tube (see part 36 on the drawing below) . Extensive investigation showed us that some of the M18X 1.5 adaptors (see part 53 on the drawing below) may not have the expected dimensions (tolerance related). We have taken appropriate production and supply actions to resolve this and implemented them immediately.

Required action: remove part 53 (F2560011) and replace by part AE010525 (Adaptor short M18x1.5 10 JIC). Also replace the copper ring S3182415
